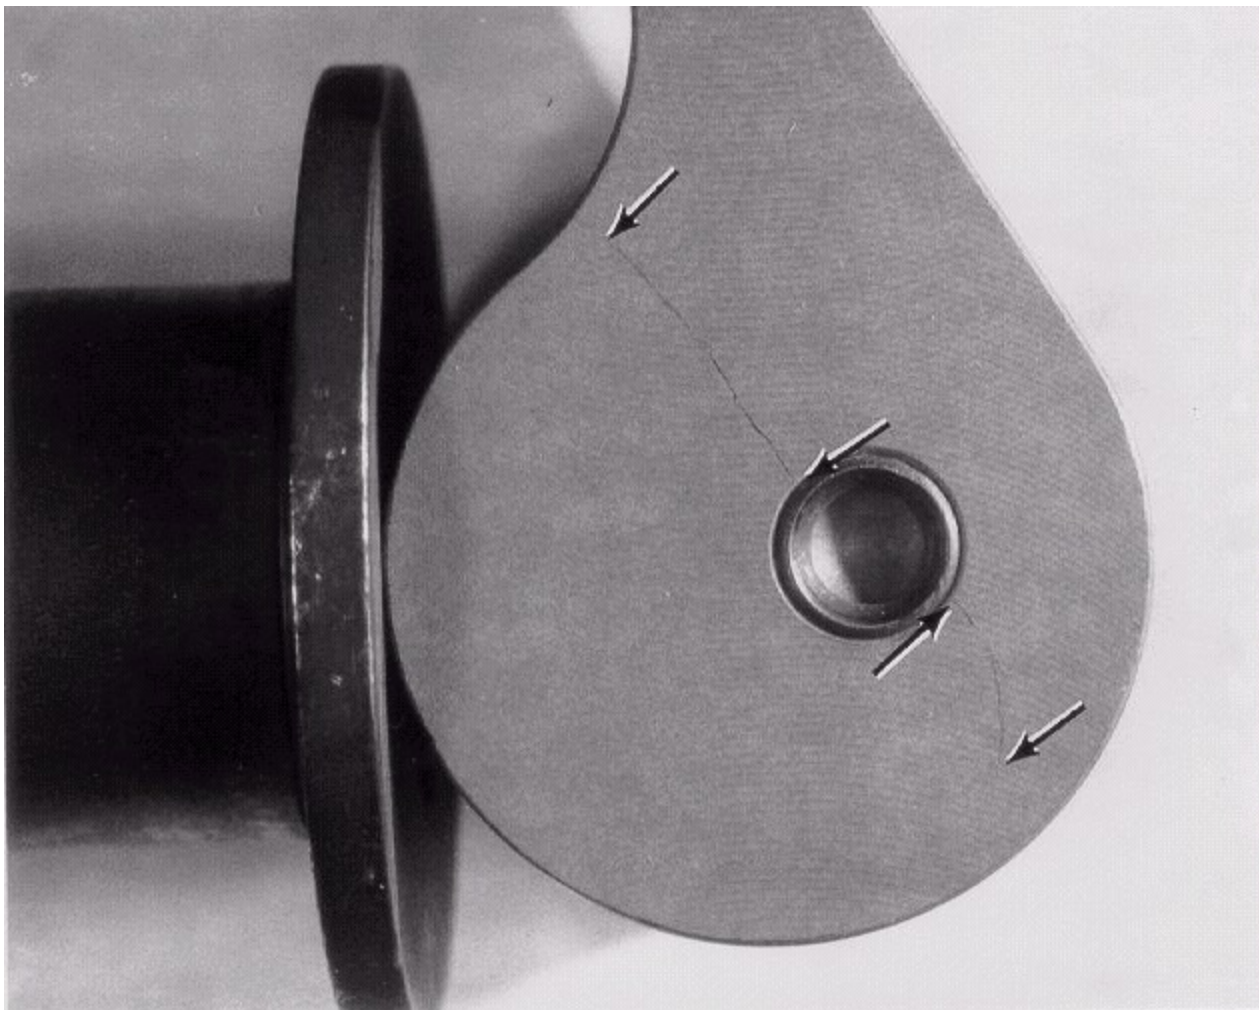
Side view of Main Rotor Expandable Pin handle. Note cracks at the arrows radiating from the attachment pin.

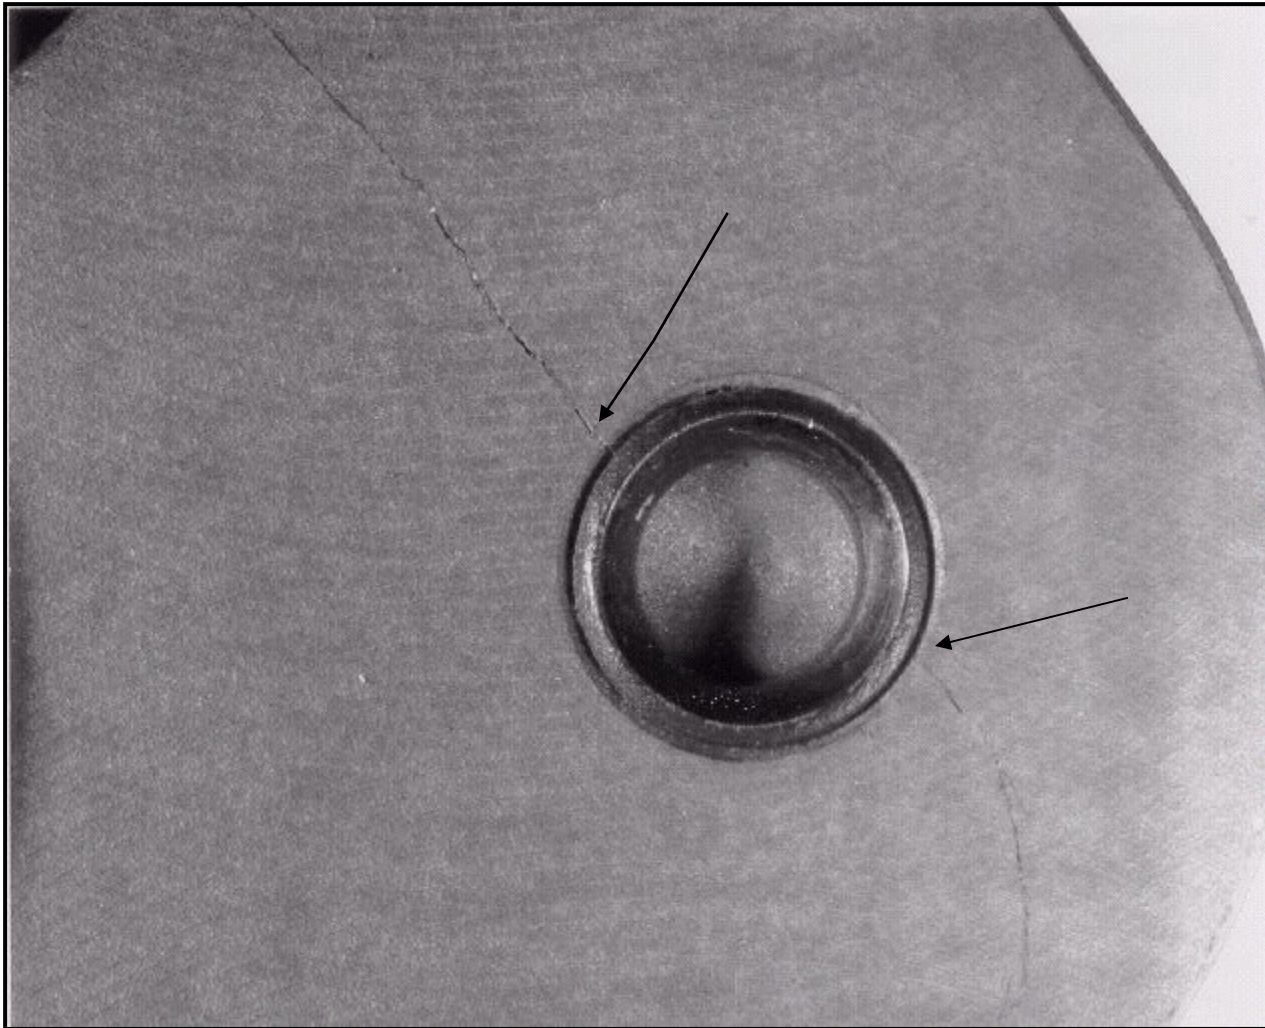
Close up of slide # 1. Note stress corrosion cracking emanating from the attachment pin.
